SEATTLE CITY LIGHT WORK ORDER #90-6 1990 SPRING MONITORING OF THE GEORGETOWN FLUME

Raven Services Corporation

September 13, 1990

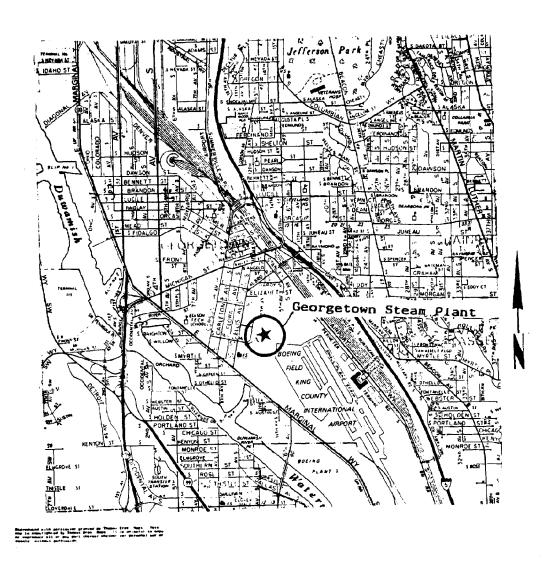
RAVEN SERVICES CORPO	DRATION
scale: = 2560 ft APPROVED BY:	DRAWN BY LSG
DATE: 6-27-90	REVISED L56-
FIG 1 SW GEORGETOWN DISTRI	SCL 054
SEATTLE CITY LIGHT	90-6(1)- 1

- 1. VICINITY MAP, GEORGETOWN FLUME
- 2. SITE & SAMPLING POSITIONS, GEORGETOWN FLUME
- 3. LOCATIONS OF STEAM PLANT DITCH SAMPLES
